# Manhole Inspection Summary

Manhole # S39AA\_044MH

Insp Date: **6/17/08 10:01 AM**

**Location** Address: **566 flat iron alley** Cross Street: **e monument st**

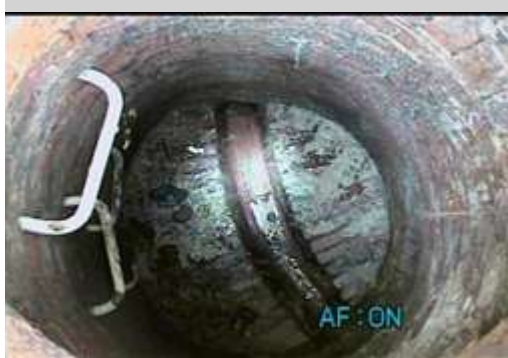
Defect 4

**Corbel** Material: **Brick** ☐ Parged Type: **Concentric/Eccentric**  
Condition: ☐ Sound ☐ Cracked ☒ Root Intrusion ☐ Loose Brick ☐ Deteriorated  
Infiltration: ☒ None ☐ Joint ☐ Cracks ☐ Mortar ☐ Roots ☐ Wall

Root infiltration in Corbel

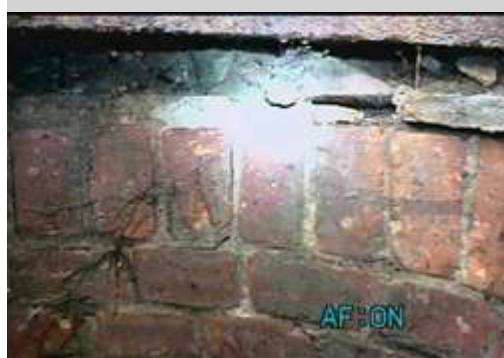
Defect 3

**Chimney / Frame Adjustment** ☒ Exists Material: **Brick and Concrete** ☐ Parged Height: **8** (in.)  
Condition: ☐ Sound ☐ Cracked ☒ Root Intrusion ☒ Loose Brick ☒ Deteriorated  
Infiltration: ☒ None ☐ Joint ☐ Cracks ☐ Mortar ☐ Roots ☐ Wall

loose bricks and deteriorating chimney,  
root infiltration in chimney

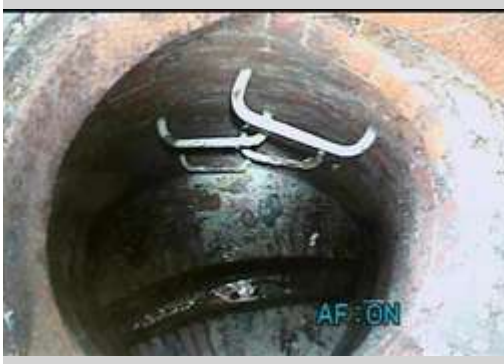
Defect 2

**Steps** Count: **4** Missing: **0** ☒ Corroded

steps

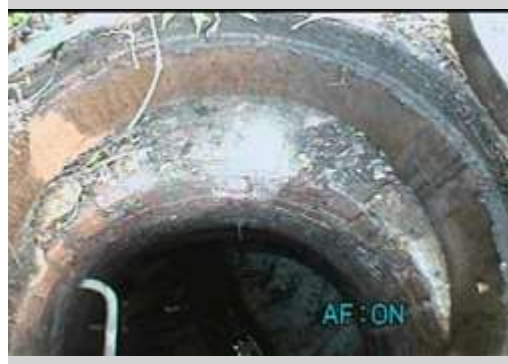
Defect 1

**Frame** Offset: **4** (in.) Condition: ☒ Sound ☐ Cracked ☐ Leaks

offset

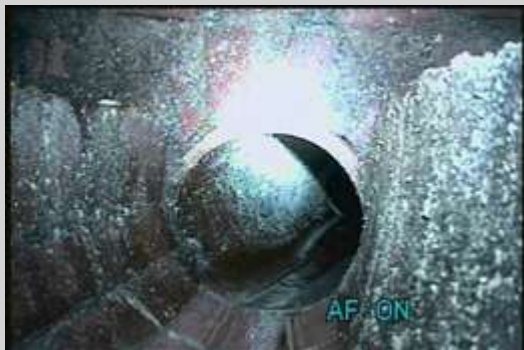
12 O'Clock Outflow

8 in. Circular Gravity Sewer  
Pipe Out @ 12 O'Clock

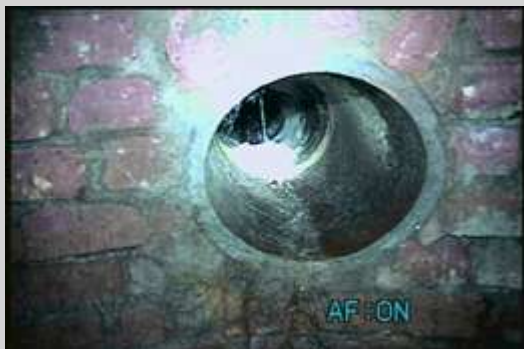
5 O'Clock Inflow

8 in. Circular Gravity Sewer  
Pipe In @ 5 O'Clock

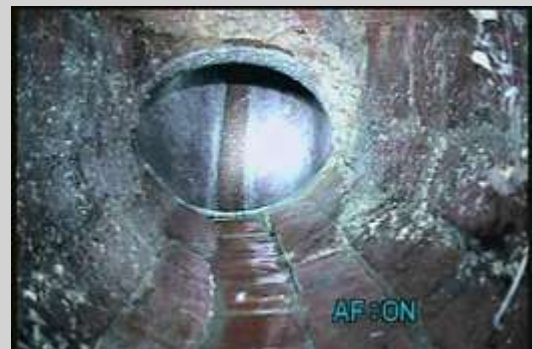
Drop In @ 5 O'Clock

Drop: Outside Direct

Drop Condition: Open
